HIGH POWER LED PROJECTION HEADLIGHT

Item Numbers: 35819, 35820, 35821, 35822

Normal Fogging / Condensation

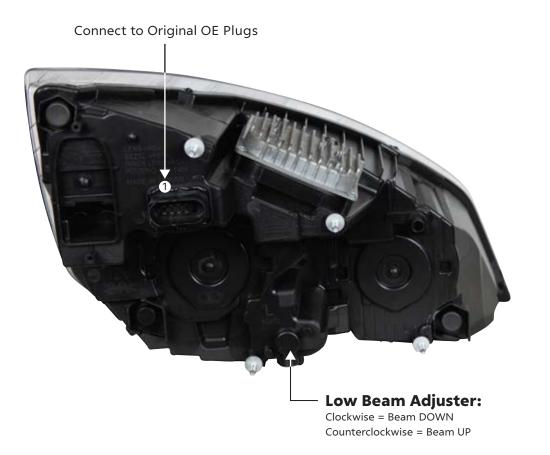
This bulletin provides information regarding headlights that may experience fogging or condensation inside of the headlamp assembly. A drop in air temperature may cause condensation to form on the inside of a cool headlamp lens. Generally, fogging is considered normal and can be eliminated by turning on the headlamp with the engine running for several minutes. In most cases, operating the vehicle in normal driving condition will clear the headlamp fogging. Headlamp assembly replacement **WILL NOT** be necessary in most cases.

- If any of the following conditions occur, please consult with a professional mechanic to determine the water source:
 - If condensation/fogging fails to dissipate after operating the headlight with the engine running for 30 minutes
 - If water pooled inside the headlamp
- A high pressure washer may also cause water to be forced into the headlamp assembly.
