# HIGH POWER PROJECTION HEADLIGHT

Item Numbers: 31094, 31095, 31096, 31097

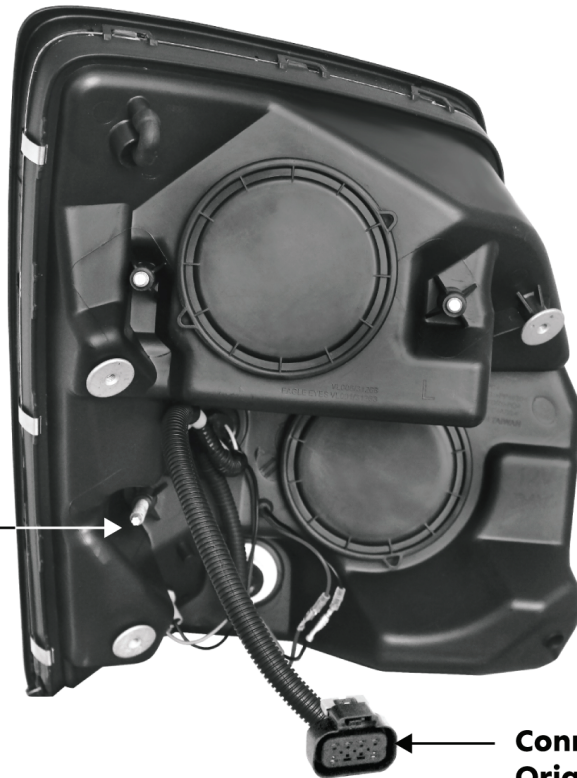
## Connect Plug to Original OE Wire Harness

### Beam Adjuster:

Clockwise  
= Beam UP  
Counterclockwise  
= Beam DOWN

Connect to  
Original OE Plug
