INTERNATIONAL PROSTAR PROJECTION HEADLIGHT

Item Numbers: 31175, 31176, 31177, 31178, 31179, 31180, 31183, 31184

LED Position Light Bar Wiring Instruction

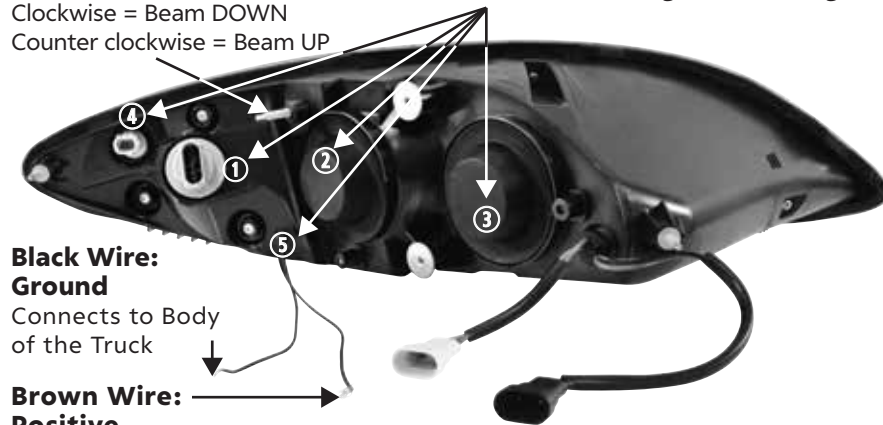
Item #31179 / 31180 / 31183 / 31184

Connect All Plugs to Original OE Wire Harness

① Turn Signal/LED Turn Signal, ② Low Beam, ③ High Beam, ④ Parking Light LED, ⑤ Position Light Bar

Note: If the position light bar flashes irregularly, the flashing is caused by improper grounding. Please attach the ground (black wire) to the body of the truck for proper grounding.

Beam Adjuster:

Clockwise = Beam DOWN
Counter clockwise = Beam UP

Connect to Original OE Plugs

Black Wire: Ground

Connects to Body
of the Truck

Brown Wire: Positive

The **Brown** Positive Wire for the LED position light must NOT be hooked into any of the OE harnesses. It is recommended this Brown Positive Wire be hooked to a 12v + source independent of the OE light harnesses. Locate a power wire which activates an accessory (e.g. dash auxiliary) when the ignition is in the "ON" position, so that the LED position light only comes on when the truck ignition is "ON" and running.

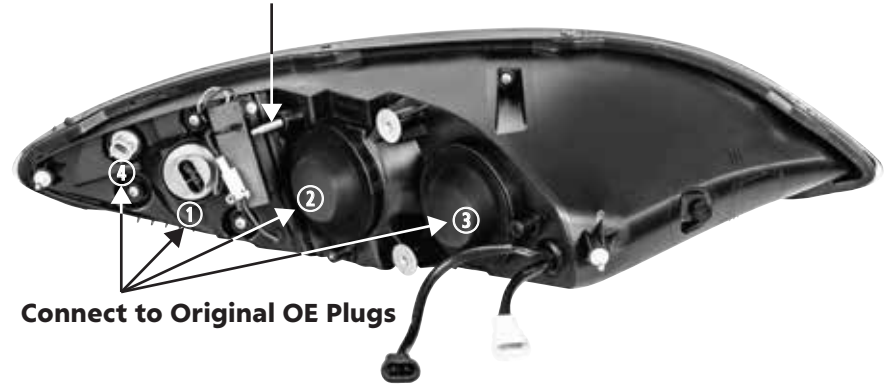
Item #31175, 31176, 31177, 31178

Beam Adjuster:

Clockwise = Beam DOWN, Counter clockwise = Beam UP

Connect to Original OE Plugs
