# DUAL FUNCTION PROJECTOR HEADLIGHT

Item Numbers: 31239, 31240, 31252, 31253

# Connector Pinout Diagrams

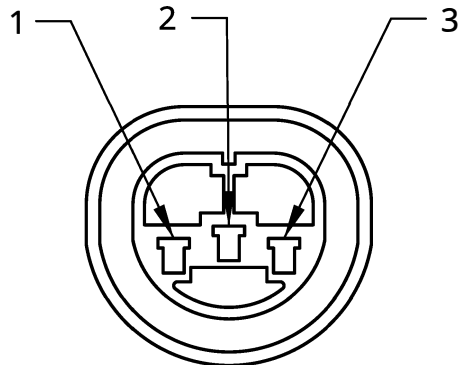
## Headlight Beam Plug

Pin#	Wire	Function	Main Plug Pin#
1	Blue/White	High Beam (+)	4
2	Black	Ground (-)	3
3	Red/Black	Low Beam (+)	5
