PROJECTION HEADLIGHT

Item Numbers: 32838, 32839, 32840, 32841

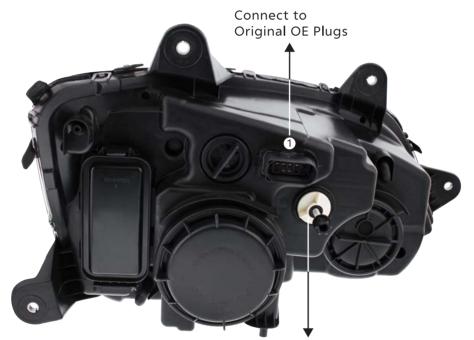
Connect Plug to Original OE Wire Harness

High & Low Beam Adjuster:

Clockwise = Beam UP
Counterclockwise = Beam DOWN
