HEADLIGHT WITH LED DRL LIGHT BAR & TURN SIGNAL FOR 2018-2023 KENWORTH W990

Item #35130, #35131, #35132, #35133

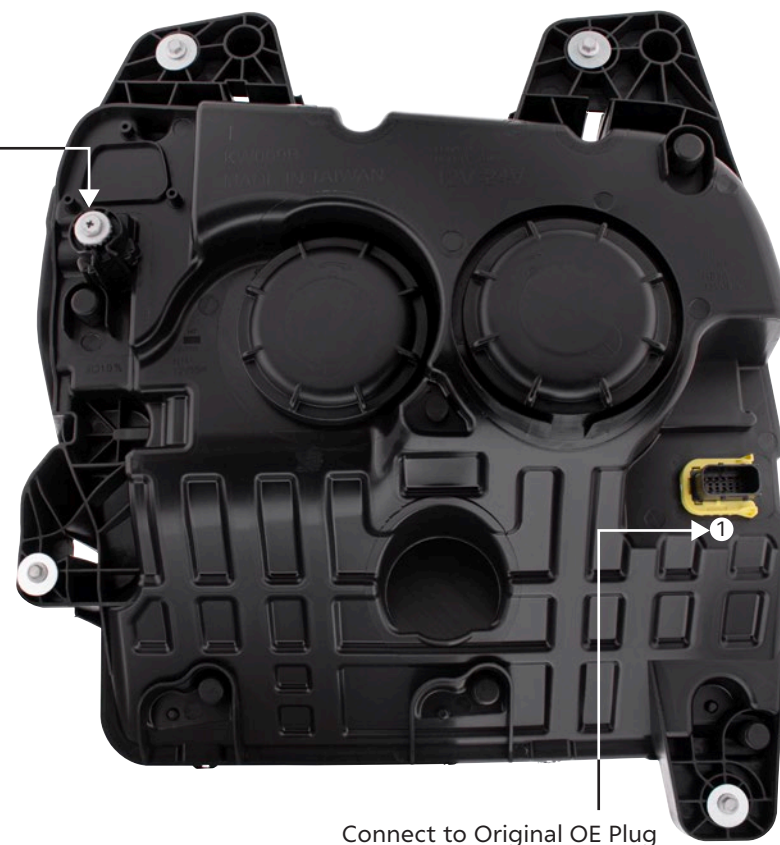
Connect Plug ① to Original OE Wire Harness

High & Low Beam Adjuster:

- Clockwise = Beam UP
- Counterclockwise = Beam DOWN
