# HIGH POWER LED PROJECTION HEADLIGHT ASSEMBLY

Item # 35911, 35912, 35913, 35914

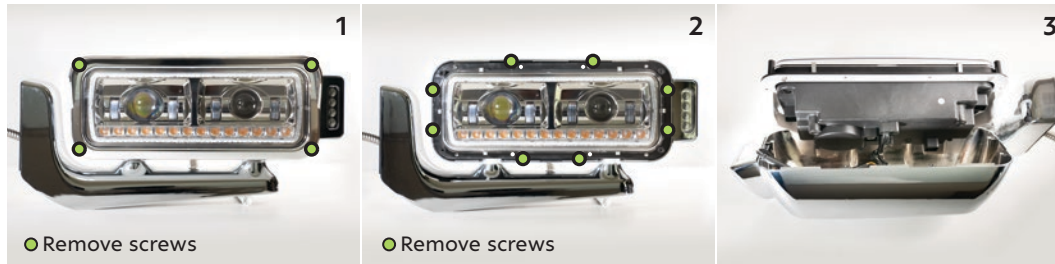
1. Remove headlight bezel by removing the 4 screws.
2. Remove headlight back housing by removing the 8 screws.
3. Carefully move the rear housing back enough to allow access to the headlight adjusters. Remove the 4 plastic caps on the back of the LED headlamp with the included nut driver tool.
4. Once headlight beam adjustment is complete, re-assembly is reverse of steps 1, 2, 3.

1. To adjust the beam:
  - Upper adjuster: clockwise = beam RIGHT  
counter clockwise = beam LEFT
  - Lower adjuster: clockwise = beam UP  
counter clockwise = beam DOWN
2. Replace the plastic caps on the adjusters when done. Reinstall rear housing (8 screws). Make sure the screws are tight. Replace headlight bezel (4 screws)
